**UNITED STATES AIR FORCE**  
**AIRCRAFT ACCIDENT INVESTIGATION**  
**BOARD REPORT**

**F-15E STRIKE EAGLE, T/N 91-000304**

**492D FIGHTER SQUADRON  
48TH FIGHTER WING  
ROYAL AIR FORCE LAKENHEATH, UNITED KINGDOM**

**DATE OF ACCIDENT: 21 MARCH 2011**

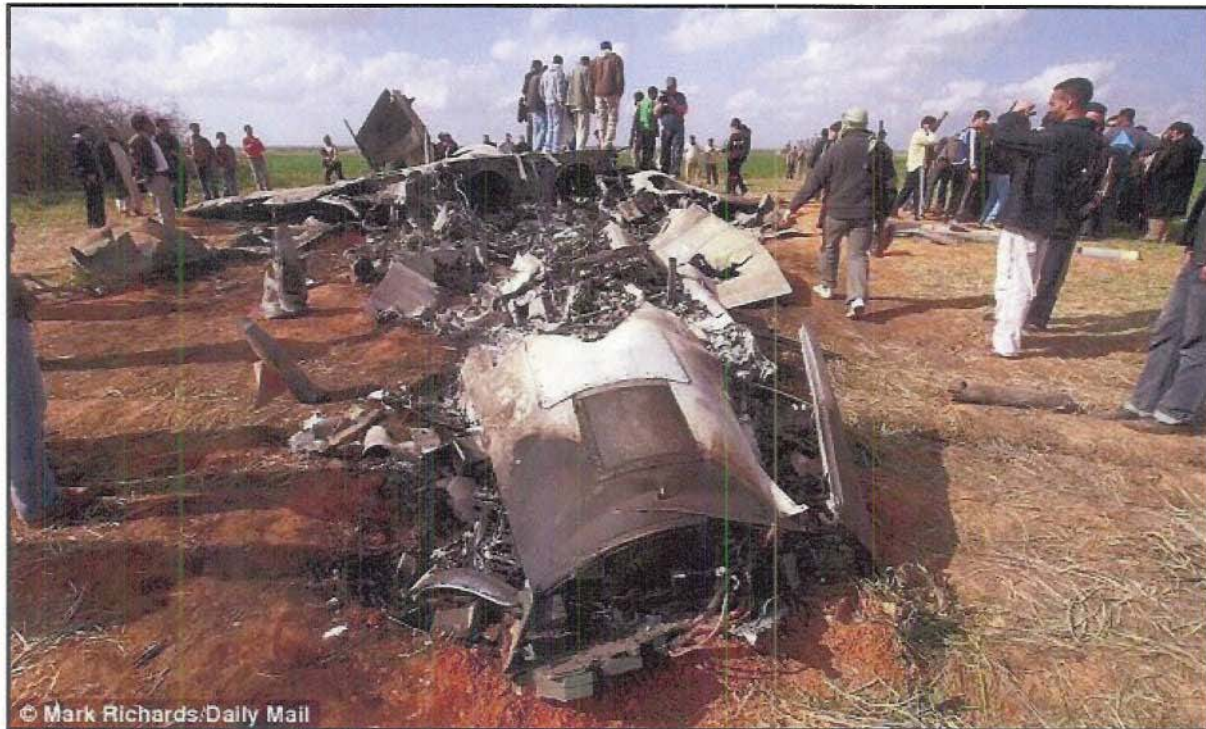
#### Front View of Mishap Aircraft's Nose Section

*The photograph shows the MA impacted the ground in a spin. This is apparent from the fact that the length of the MA is not significantly compressed, the aircraft nose is compressed flat on the ground, and the ground around the nose section is not cratered or significantly scarred.*

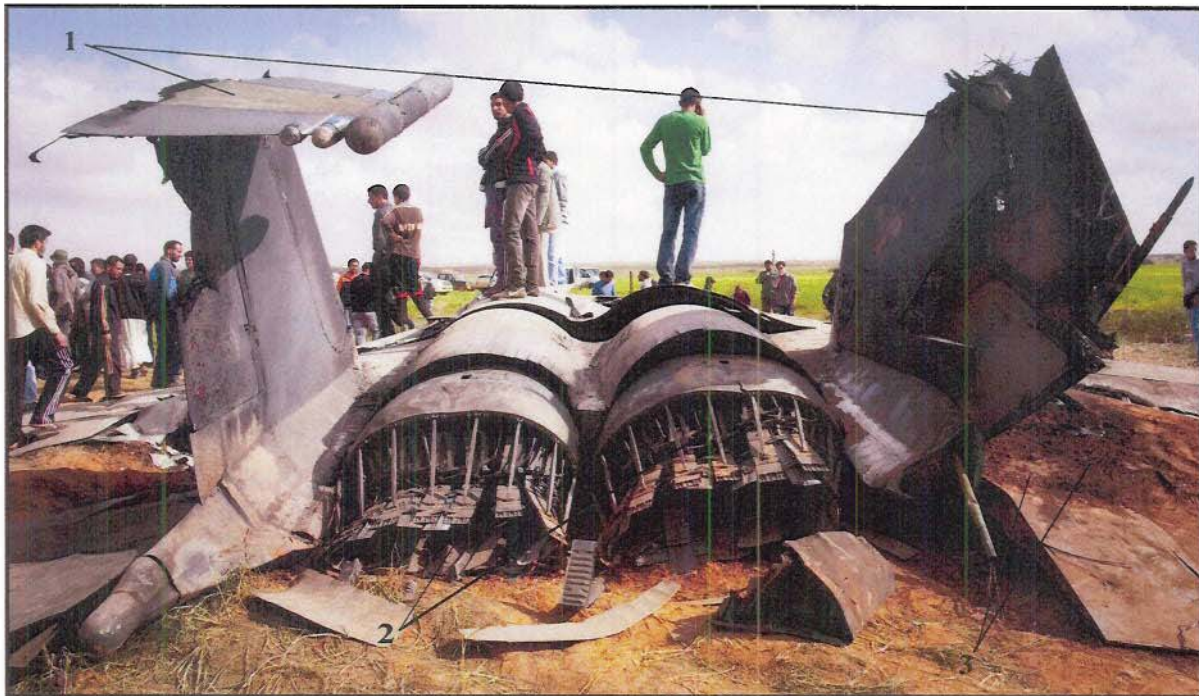
## Back View of Mishap Aircraft on Impact

*The photograph shows the MA was rotating left upon impact. The flat left spin rotation is evident from (1) the tops of the vertical tails which are mainly intact; (2) the compressed engine nozzles; and (3) the soil covering the right horizontal stab.*

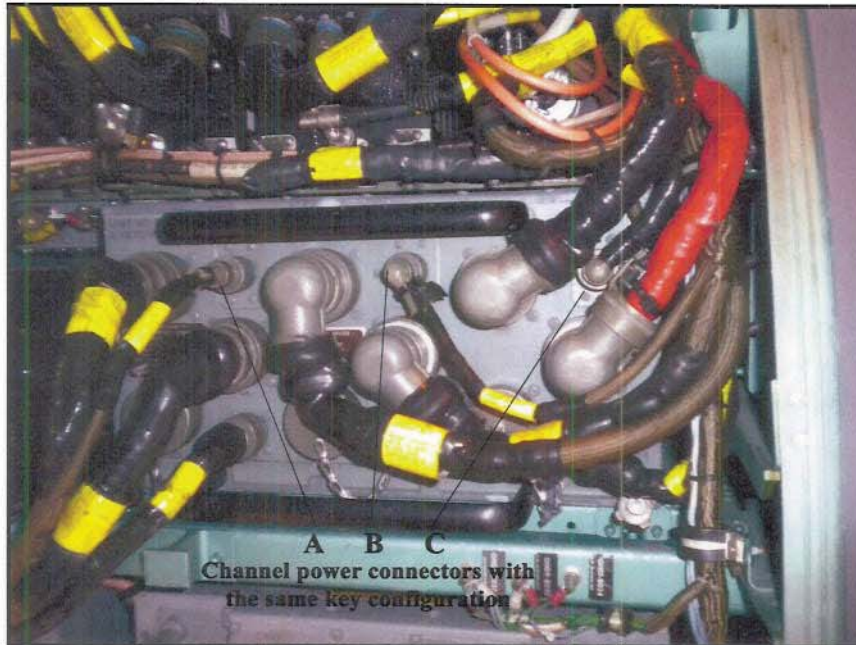
### FCC Channel Power Connectors

*The photo above shows properly configured FCC connections. Of note, the A, B, and C channel power connectors all have the same connector/receptacle key configuration. The B and C connectors are often mistakenly reversed during installation due to the matching connector/receptacle key configuration and the close proximity to each other.*
