FAIREWINDS ASSOCIATES

New Images Reveal Nuclear Fuel Rack Exposed to Air

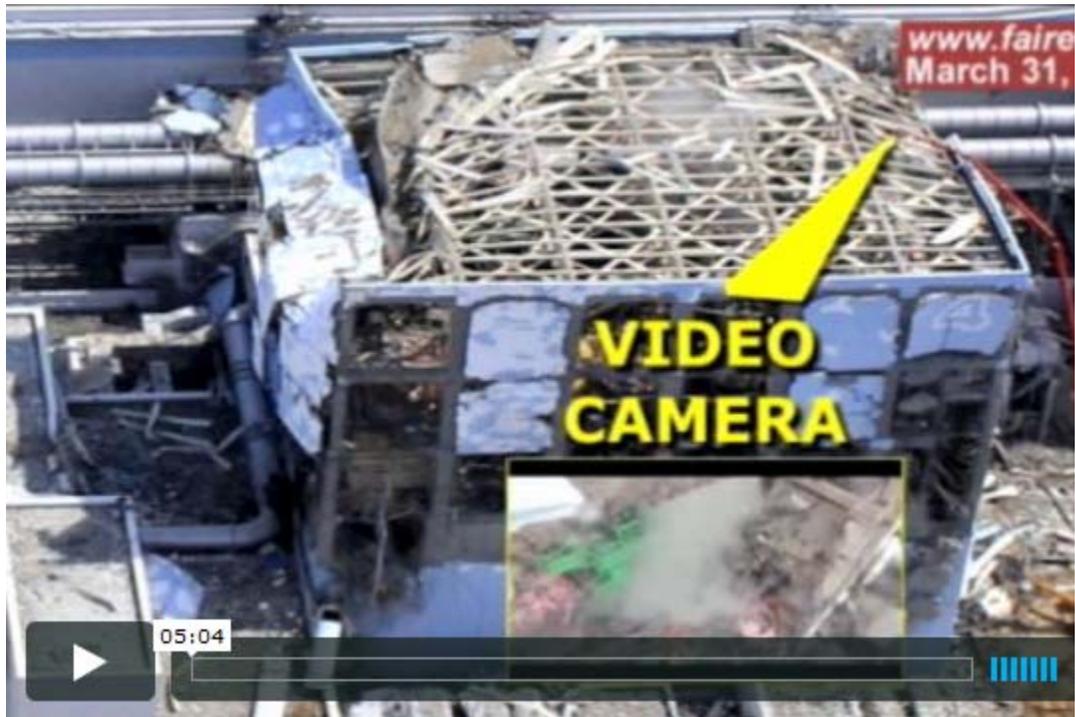
This picture is undated, but when it was taken, it clearly shows that there is no water. You look, there's a green, a long, green device. That's the refueling bridge. It runs along on rails above the pool, and the pool is that crystal-clear water that you're seeing. Well, after the explosion it has collapsed and is lying in the pool. Between seconds thirty-seven on this video you can see little boxes. The little boxes are just to the left of the bridge. The boxes are in air. Those boxes are the top of nuclear fuel racks. They are under thirty feet of water. They're not.

What that means to me is a couple things. First off, the top of the nuclear fuel is exposed, but certainly the top is. You can see steam coming from the top of the fuel. [From] down further in the cavity there is steam coming up. So they're spraying in and hitting the nuclear fuel and creating steam, but it's not filling the pool. The water has two purposes: cooling, but also shielding. That means the fuel. That [unshielded fuel] emits gamma rays, and the gamma rays go up into the sky, through molecules through something called "sky shine," and rain back down on the site as a radiation that's much higher than normal. That makes work on the site really difficult. Work on that refueling pool almost lethal.
