As workers enter unit 2, TEPCO recounts events inside unit 4 spent fuel pool

22 June 2011

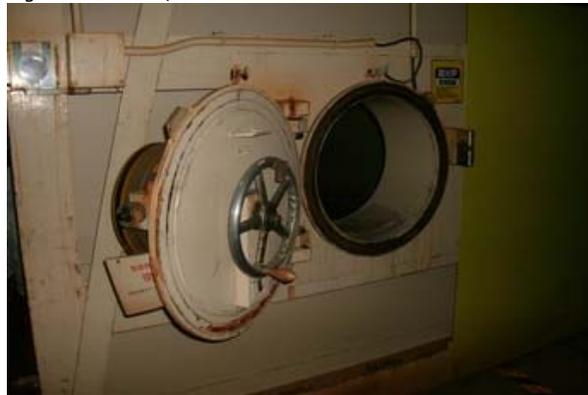
Fukushima Daiichi Unit 2 emergency exit; Image taken on 20 June as reactor building airlock opened

An investigation of the Fukushima Daiichi unit 2 reactor building ground floor and first floor found radiation levels as high as 430 mSv/hr.

Levels were 42 mSv/hr at the gauge racks. The maximum dose of the 10-man team in the 10-minute tour was 5.52 mSv.
