UNITED STATES AIR FORCE
ABBREVIATED AIRCRAFT ACCIDENT INVESTIGATION
BOARD REPORT

MQ-1B, T/N 03-3122

**18TH RECONNAISSANCE SQUADRON
432D AIR EXPEDITIONARY WING
Creech Air Force Base, Nevada**

SUBJECT: Abbreviated Accident Investigation Board Report MQ-1B, T/N 03-3122, Kandahar, Afghanistan, 30 January 2012

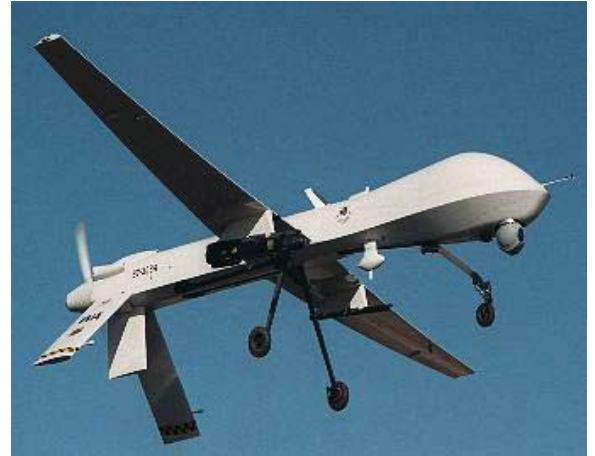
The MQ-1 Predator is an armed, multimission, medium-altitude, long endurance remotely piloted aircraft (RPA) that is employed primarily in a killer/scout role as an intelligence collection asset and secondarily against dynamic execution targets. The MQ-1's capabilities make it uniquely qualified to conduct irregular warfare operations in support of Combatant Commander objectives. (Tab CC-11).

The Predator is part of an Unmanned Aircraft System, or UAS, not just an aircraft. A fully operational UAS consists of four sensor/weapon equipped aircraft, a ground control station (GCS), a Predator Primary Satellite Link (PPSL), and spare equipment along with operations and maintenance crews for deployed 24-hour operations (Tab CC-11).
