UNITED STATES AIR FORCE
AIRCRAFT ACCIDENT INVESTIGATION
BOARD REPORT

MQ-1B, T/N 07-3182

AIRCRAFT ACCIDENT INVESTIGATION MQ-1B PREDATOR, T/N 07-3182 KANDAHAR AIRFIELD, AFGHANISTAN 5 May 2011

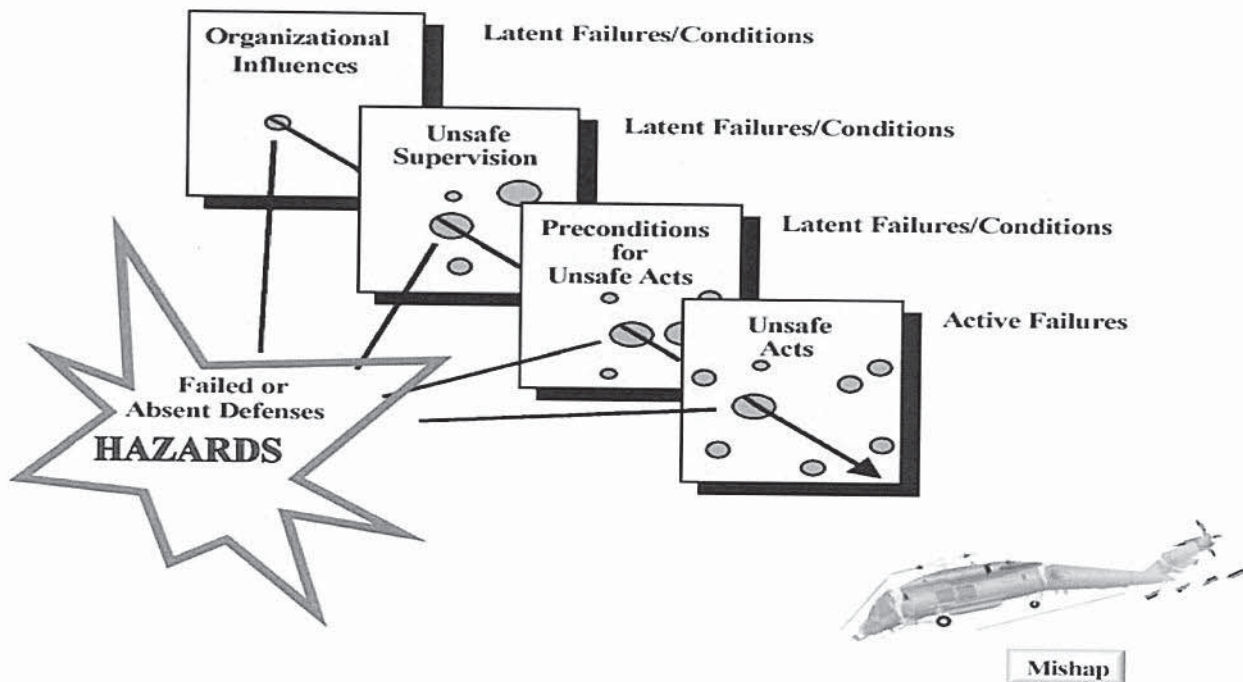
The investigation process endeavors to detect and identify failed or absent defenses (hazards), which can be visually depicted by the "Swiss Cheese" model (adapted from Reason, 1990), as seen below:

A DoD taxonomy was developed to identify hazards and risks, called the DoD Human Factors Analysis and Classification System (DOD-HFACS). DOD-HFACS describes four main tiers of failures/conditions: **1) Acts** **2) Preconditions** **3) Supervision** and **4) Organizational Influences**.
