## Status of the Nuclear Reactors at the Fukushima Daiichi Power Plant

None of the six reactors at the plant have operated since the earthquake. But explosions have damaged four of the buildings, and fuel in the reactors and spent fuel stored in the buildings has partially melted, releasing radioactive materials. Updated as of April 29, 4 p.m. EDT. All reactor status updates are listed in Japan time.

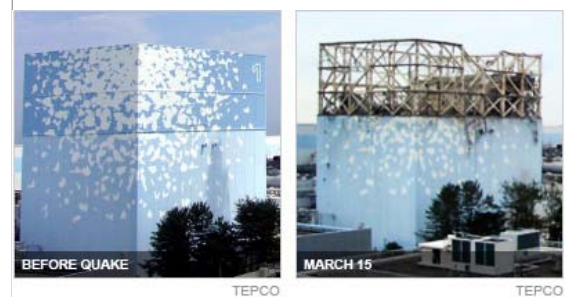
[Show More Updates](#)  
There was a partial meltdown of the reactor's fuel assemblies (about 55 percent of the fuel was damaged, according to latest estimates) and radioactive materials have leaked into the environment, in large but unknown quantities. The steel reactor core may have been breached by molten fuel.

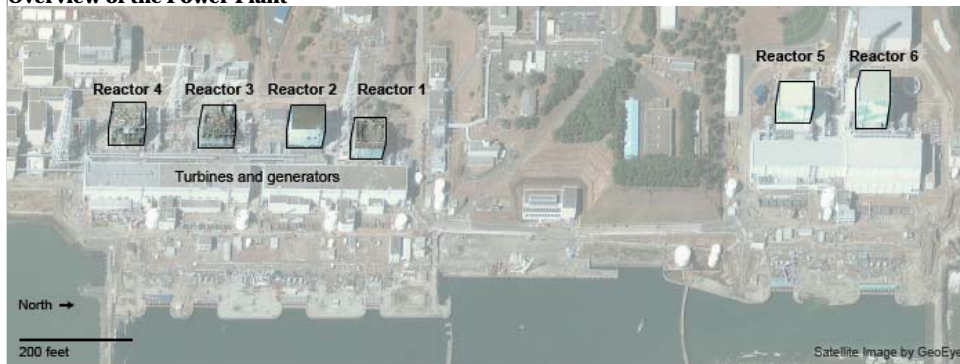
**Overview of the Power Plant**

Satellite photos by Digital Globe
