Status of the Nuclear Reactors at the Fukushima Daiichi Power Plant

None of the six reactors at the plant have operated since the earthquake. But explosions have damaged four of the buildings, and fuel in the reactors and spent fuel stored in the buildings has partially melted, releasing radioactive materials. Updated as of April 29, 4 p.m. EDT. All reactor status updates are listed in Japan time.

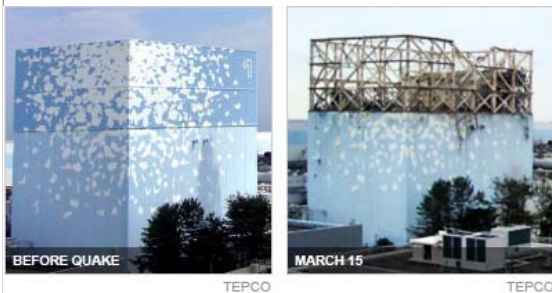
Reactor 1

There was a partial meltdown of the reactor's fuel assemblies (about 55 percent of the fuel was damaged, according to latest estimates) and radioactive materials have leaked into the environment, in large but unknown quantities. The steel reactor core may have been breached by molten fuel.

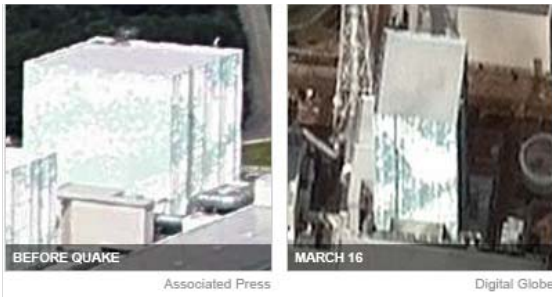
Reactor 6

The reactor is shut down and the building is not damaged. As power has been restored, concern about that this part of the facility has abated.
