UPDATED May 1, 2011

Status of the Nuclear Reactors at the Fukushima Daiichi Power Plant

None of the six reactors at the plant have operated since the earthquake. But explosions have damaged four of the buildings, and fuel in the reactors and spent fuel stored in the buildings has partially melted, releasing radioactive materials. Updated as of April 29, 4 p.m. EDT. All reactor status updates are listed in Japan time.

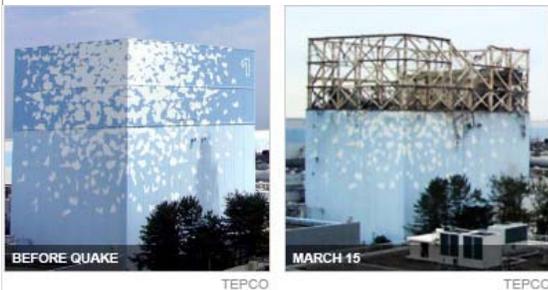
Reactor 1

There was a partial meltdown of the reactor's fuel assemblies (about 55 percent of the fuel was damaged, according to latest estimates) and radioactive materials have leaked into the environment, in large but unknown quantities. The steel reactor core may have been breached by molten fuel.

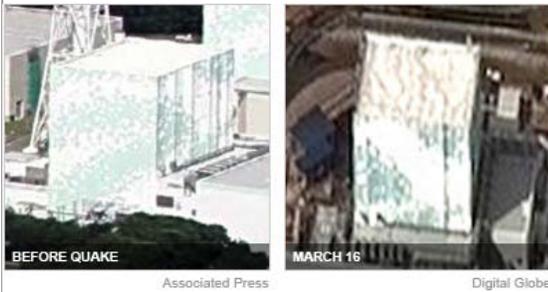
Reactor 5

The reactor is shut down and the building is not damaged. As power has been restored, concern about that this part of the facility has abated.

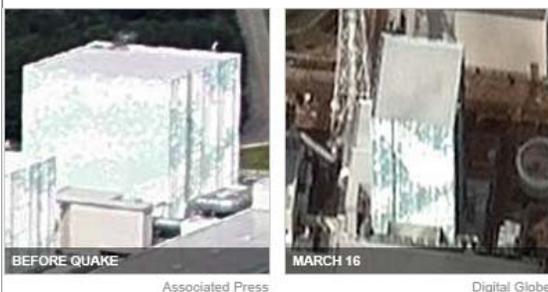
Reactor 6

The reactor is shut down and the building is not damaged. As power has been restored, concern about that this part of the facility has abated.
